Boating Safety Circular 86

BOATING AND CARBON MONOXIDE POISONING A DANGEROUS COMBINATION

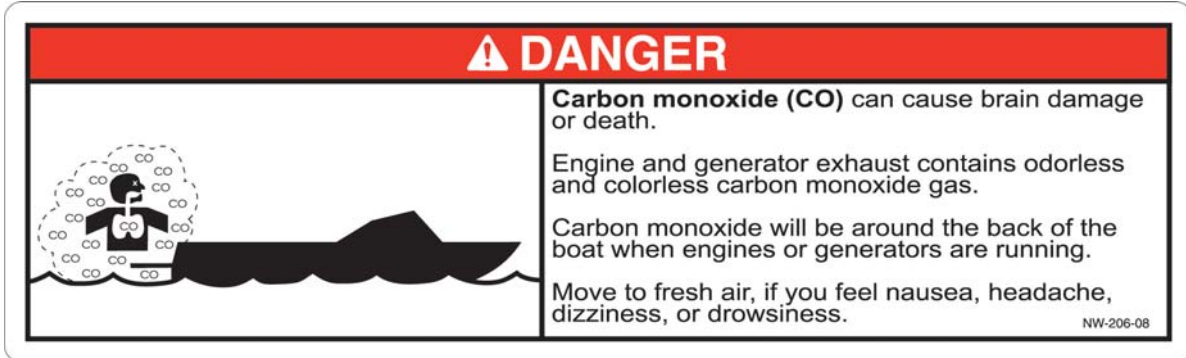
(NW 206-08) This label is required on all boats sold in the State of California in accordance with AB2222.

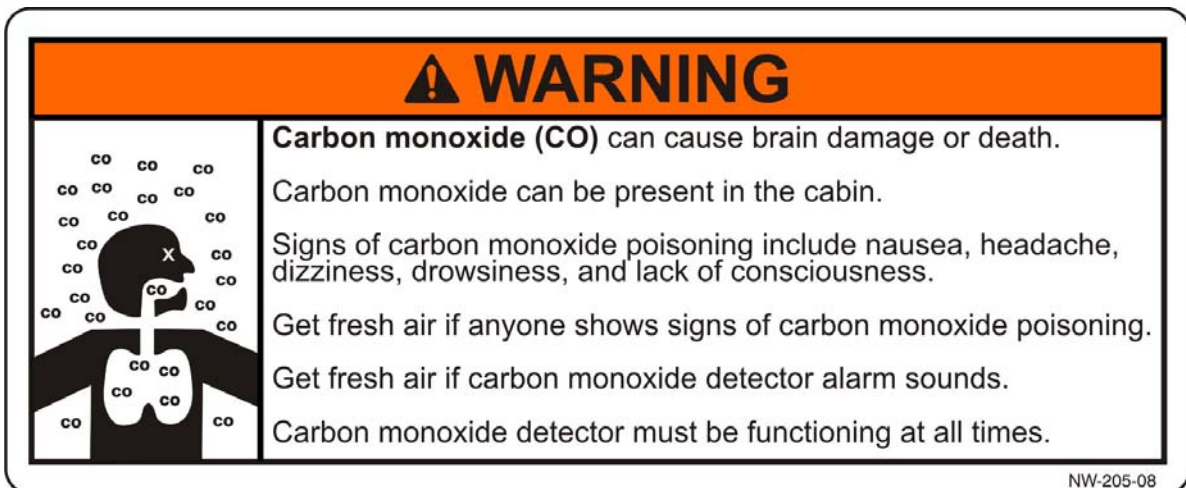
CO CABIN LABEL

(NW 205-08)
